Landmarks Preservation Commission  
January 5, 1993; Designation List 248  
LP-1839

## MOUNT MORRIS BANK BUILDING

(later the Corn Exchange Bank, Mount Morris Branch),  
81-85 East 125th Street, aka 1820 Park Avenue, Borough of Manhattan.  
Built 1883-84, enlarged 1889-90; architects Lamb & Rich.

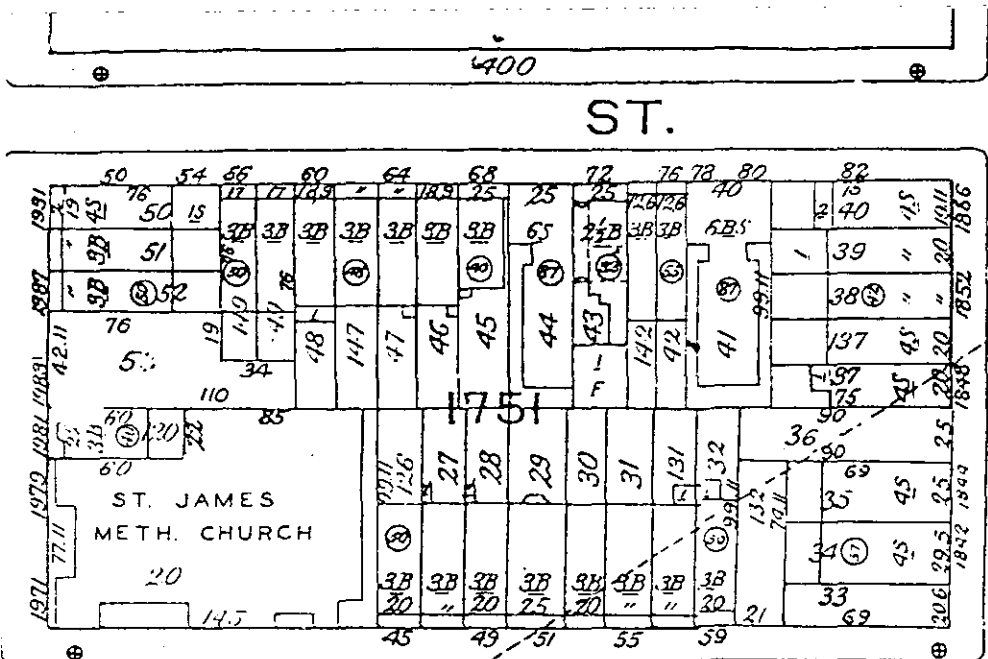
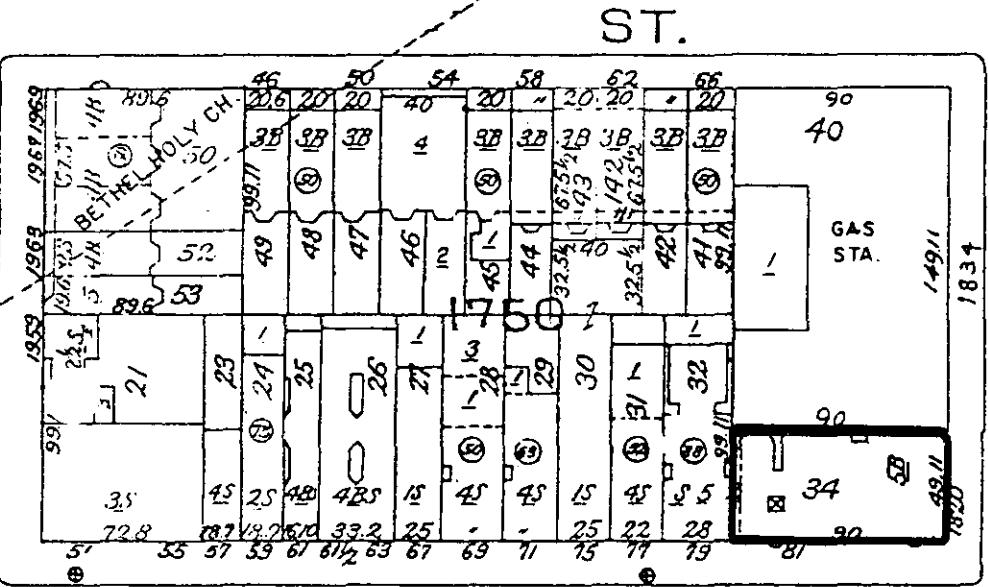
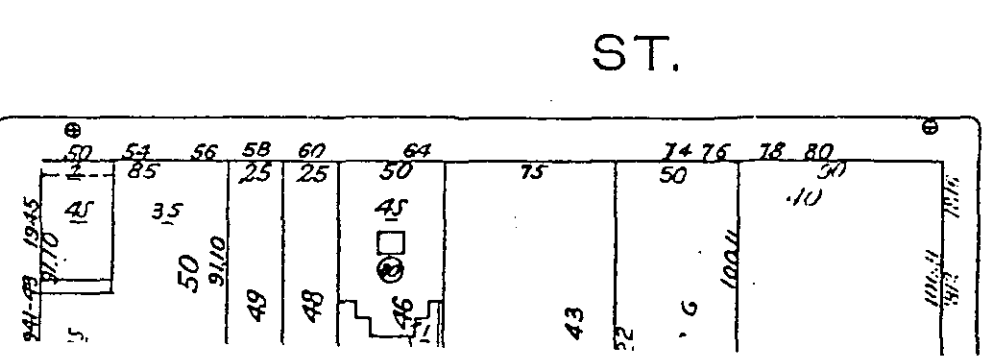
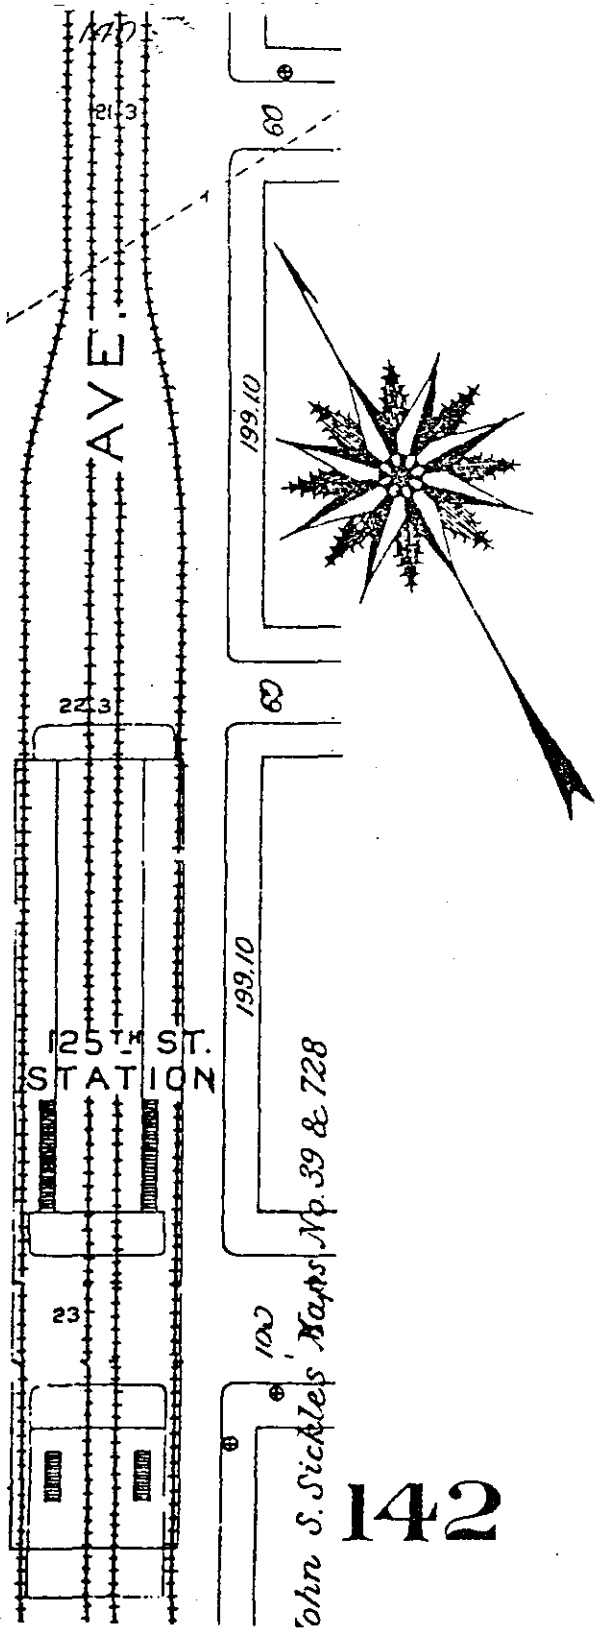
Mount Morris Bank Building (later the Corn Exchange Bank, Mount Morris Branch)  
 81-85 East 125th Street, aka 1820 Park Avenue, Manhattan  
 Landmark Site  
 Graphic Source: *Sanborn Manhattan Land Book*, 1988-89.

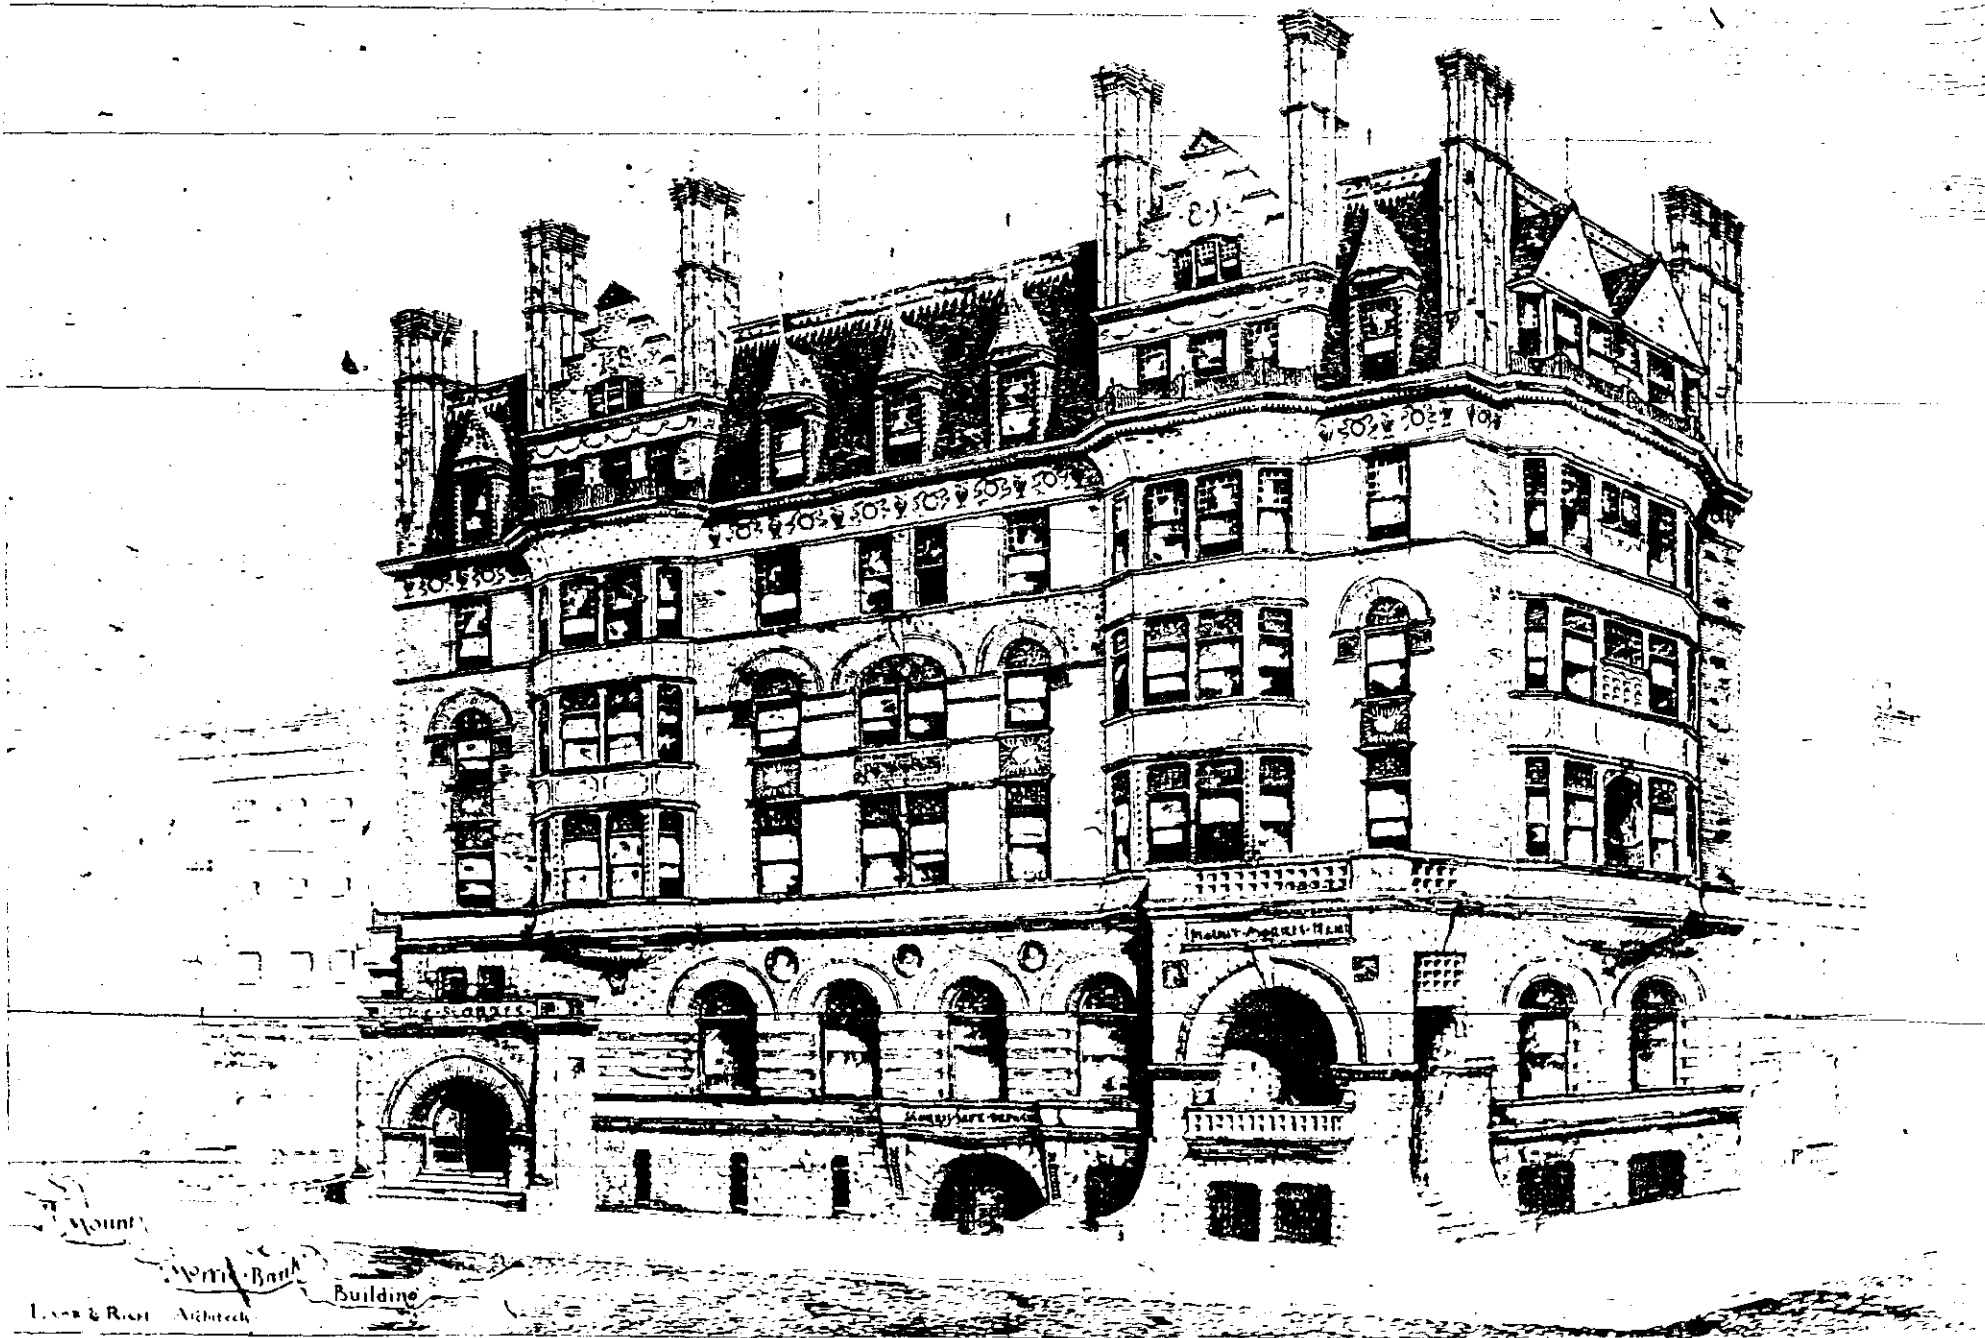
"Mount Morris Bank-Building, New York, N.Y. Messrs. Lamb & Rich, Architects, New York, N.Y." *American Architect and Building News* 13 (April 28, 1883). This indicates the appearance of the building before it was enlarged in 1889-90.

The building was constructed with commercial space on the lower stories and six flats on the upper stories. According to a plate of the building published in *American Architect* (April 28, 1883), the apartment house was called "The Morris." In 1874, the Department of Buildings created the classification of "French flat" to describe multiple dwellings with apartments containing private baths and toilets. By the 1880s flats were becoming acceptable places of habitation for the middle class. In a variant on the standard flat house, many imposing buildings were erected with commercial space for a prestigious owner or tenant on the lower floors and apartments above. Besides the Mount Morris Bank Building, other examples of this multi-use type include the Gorham Building (Edward Kendall, 1883-84; a designated New York City Landmark) on Broadway and East 19th Street, and the Wilbraham (D. & J. Jardine, 1888-89) on Fifth Avenue and West 30th Street. However, by the early twentieth century, the flats above the Mount Morris Bank had been converted into offices.

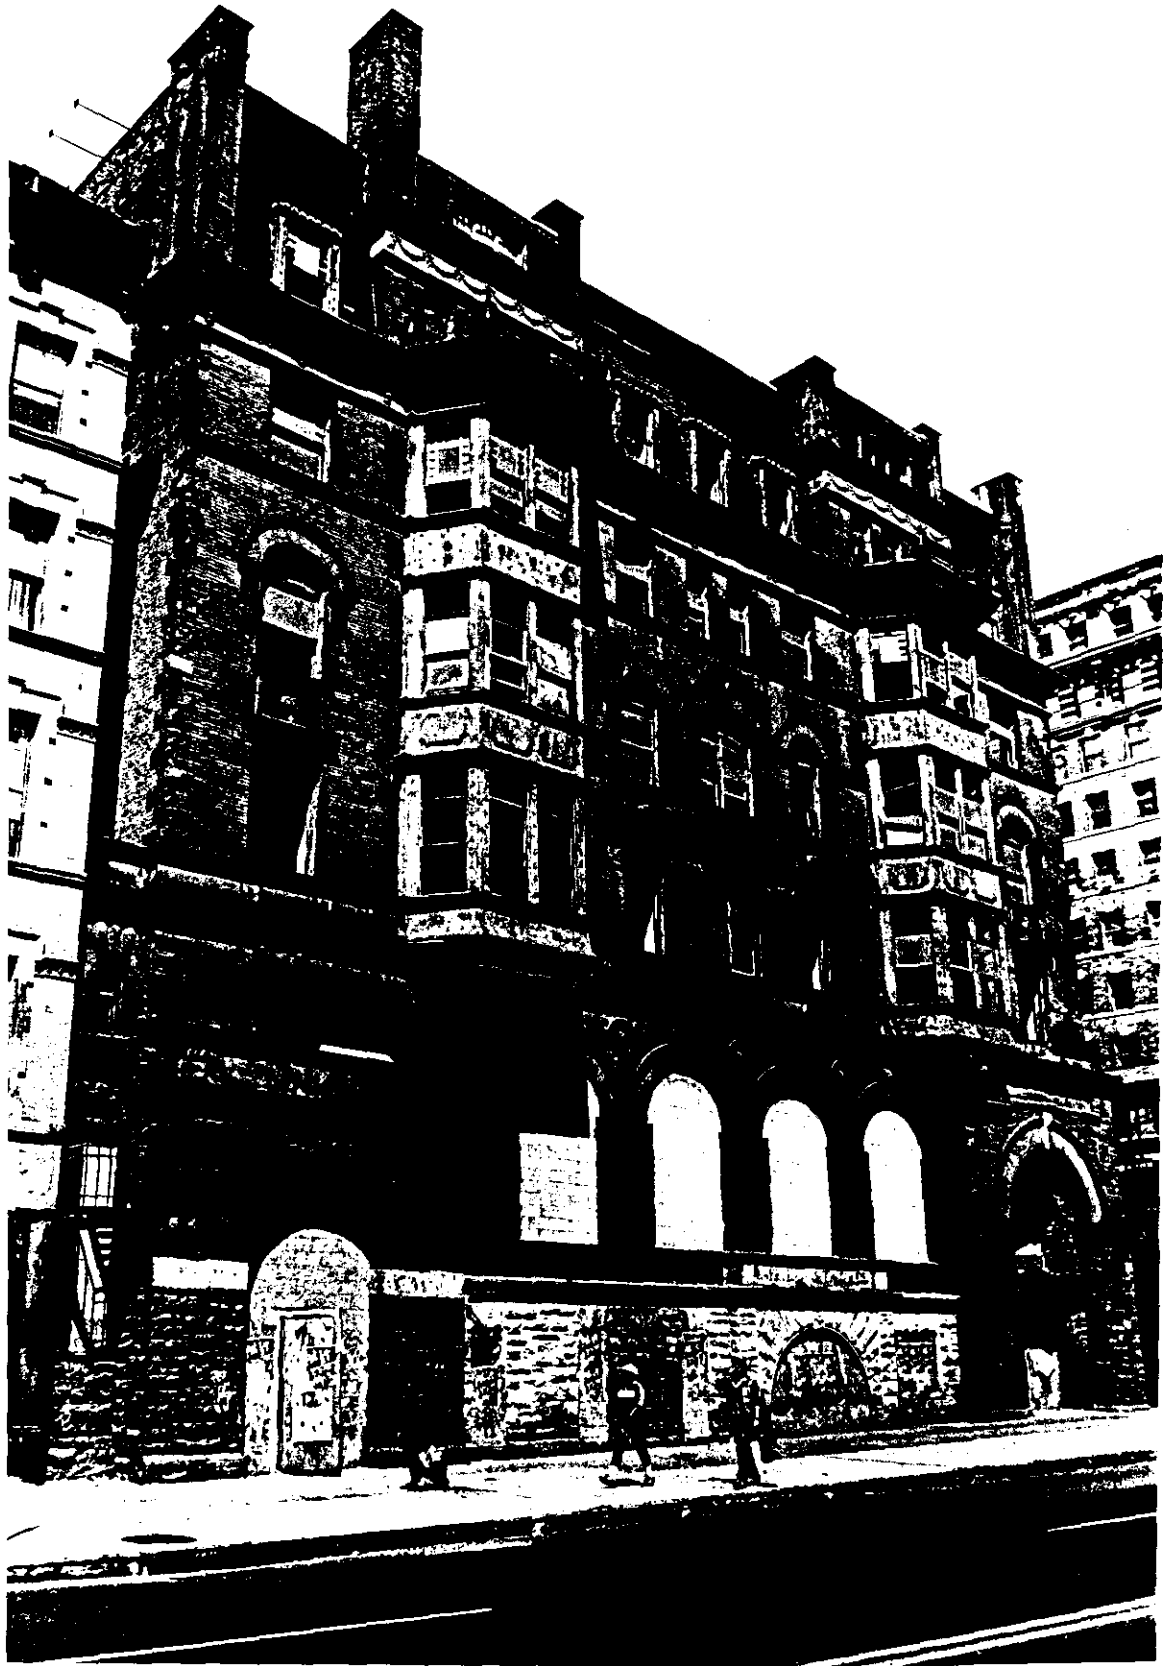
Mount Morris Bank Building (later the Corn Exchange Bank, Mount Morris Branch)  
81-85 East 125th Street, aka 1820 Park Avenue, Manhattan  
(Photo: Landmarks Preservation Commission, Jenny McCloskey)

The former Mount Morris Bank Building has six stories set on a raised basement. A rock-faced sandstone base incorporates the entire basement level and the first-story entrance pavilions; the upper stories are clad in red Philadelphia brick. The building extends ninety feet along 125th Street and slightly less than fifty feet (originally twenty-five feet) along Park Avenue. The basement, which was originally the location of the safe deposit vaults (and the home of the Mount Morris Safe Deposit Company), is partially raised above ground level. The vaults were reached via a round-arched below-grade entrance set slightly to the east of the center of the building on 125th Street. The entrance steps were removed in 1912 and the sidewalk extended over most of the entry area; only the top of the entrance arch survives. To the right of the arch is a single rectangular window, while to the left are three small windows, one of which retains its original iron

On the 125th Street facade, the four upper stories are symmetrically massed. The second through fourth stories are faced with red brick enlivened with rock-faced stone quoins and terra-cotta trim. The most prominent feature of this section is the pair of three-story, three-sided, angular, galvanized-iron oriels located one bay in from each end of the building. Each oriel rests on a stone

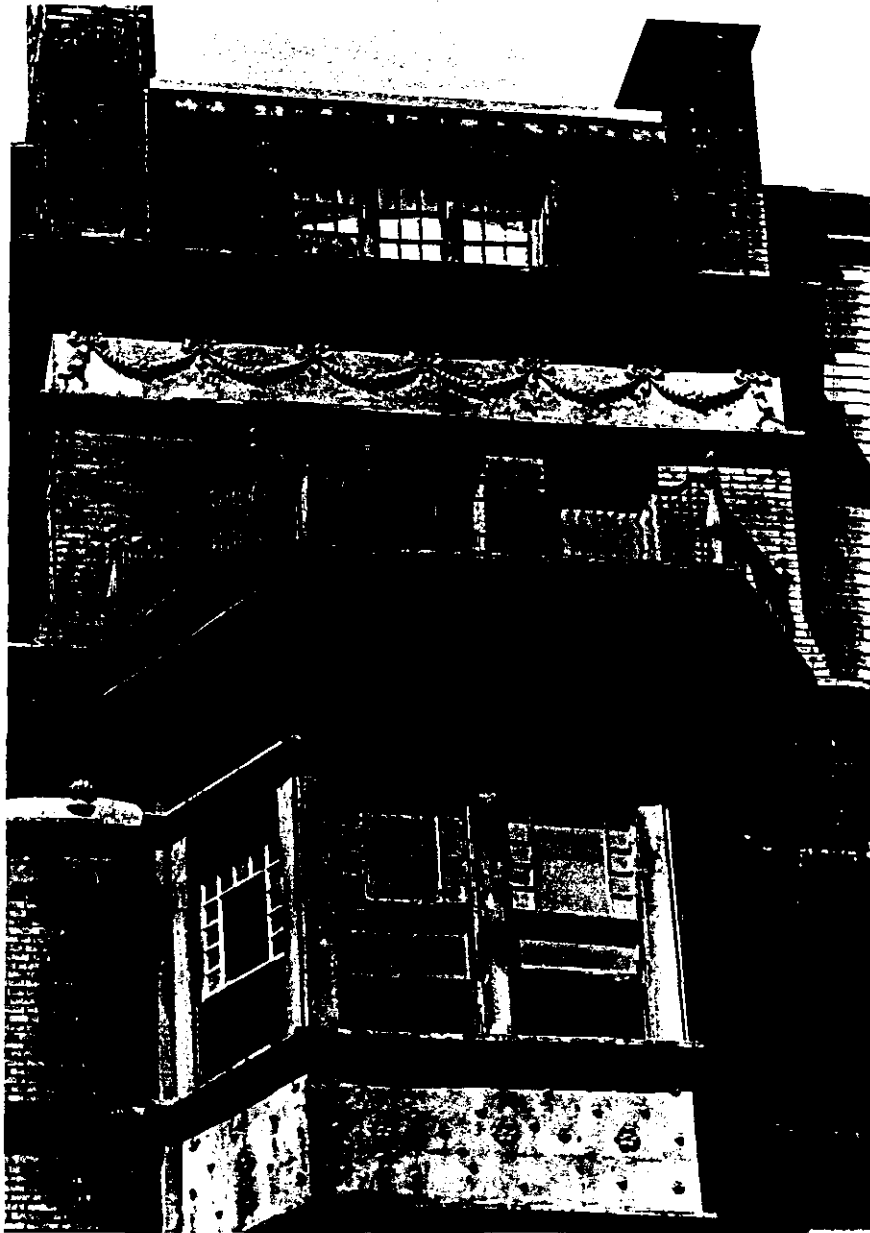
Mount Morris Bank Building (later the Corn Exchange Bank, Mount Morris Branch)  
81-85 East 125th Street, aka 1820 Park Avenue, Manhattan  
Detail of window oriel  
(Photo: Landmarks Preservation Commission, Jenny McCloskey)

corbel; the eastern oriel is also supported by a bracket that sits on the corner of the entrance enframingent. The oriels are ornamented with bosses, rosettes, and projecting panels. All of the windows, including stained-glass transoms, have been removed. Each oriel is crowned by a wrought-iron railing.

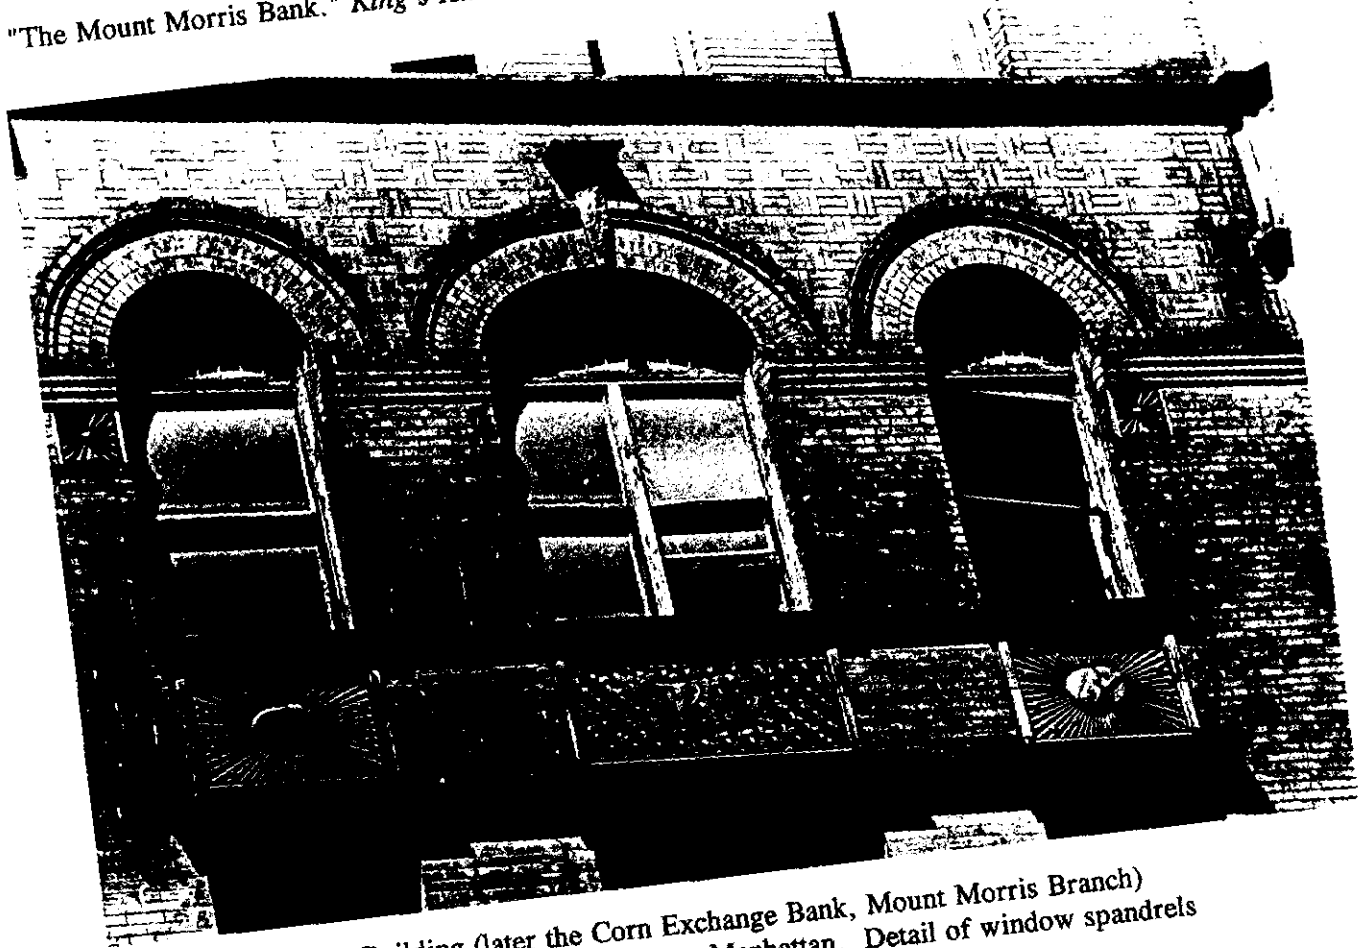
Mount Morris Bank Building (later the Corn Exchange Bank, Mount Morris Branch)  
81-85 East 125th Street, aka 1820 Park Avenue, Manhattan. Detail of window spandrels  
(Photo: Landmarks Preservation Commission, Jenny McCloskey)

located in the center of the fourth story; terra-cotta basketweave panels with garlands and panels with sunbursts and shields, all set between the second- and third-story windows; a two-story stepped gable (the steps have been removed and a stone coping constructed) articulated by six rectangular fifth-story windows separated by stone columns and by two round-arched sixth-story windows; and an ornate wrought-iron ladder that probably led to the ornate iron balconies that once extended in front of the windows on the second through fifth floors (now replaced by simple iron balconies).
