Landmarks Preservation Commission
April 16, 1991; Designation List 234
LP-1673

104 RIVERSIDE DRIVE HOUSE, 104 Riverside Drive, Borough of Manhattan. Built 1898-99, architect Clarence F. True. Altered 1910-11 by Clinton & Russell.

Landmark Site: Borough of Manhattan Tax Map Block 1245, Lot 46.

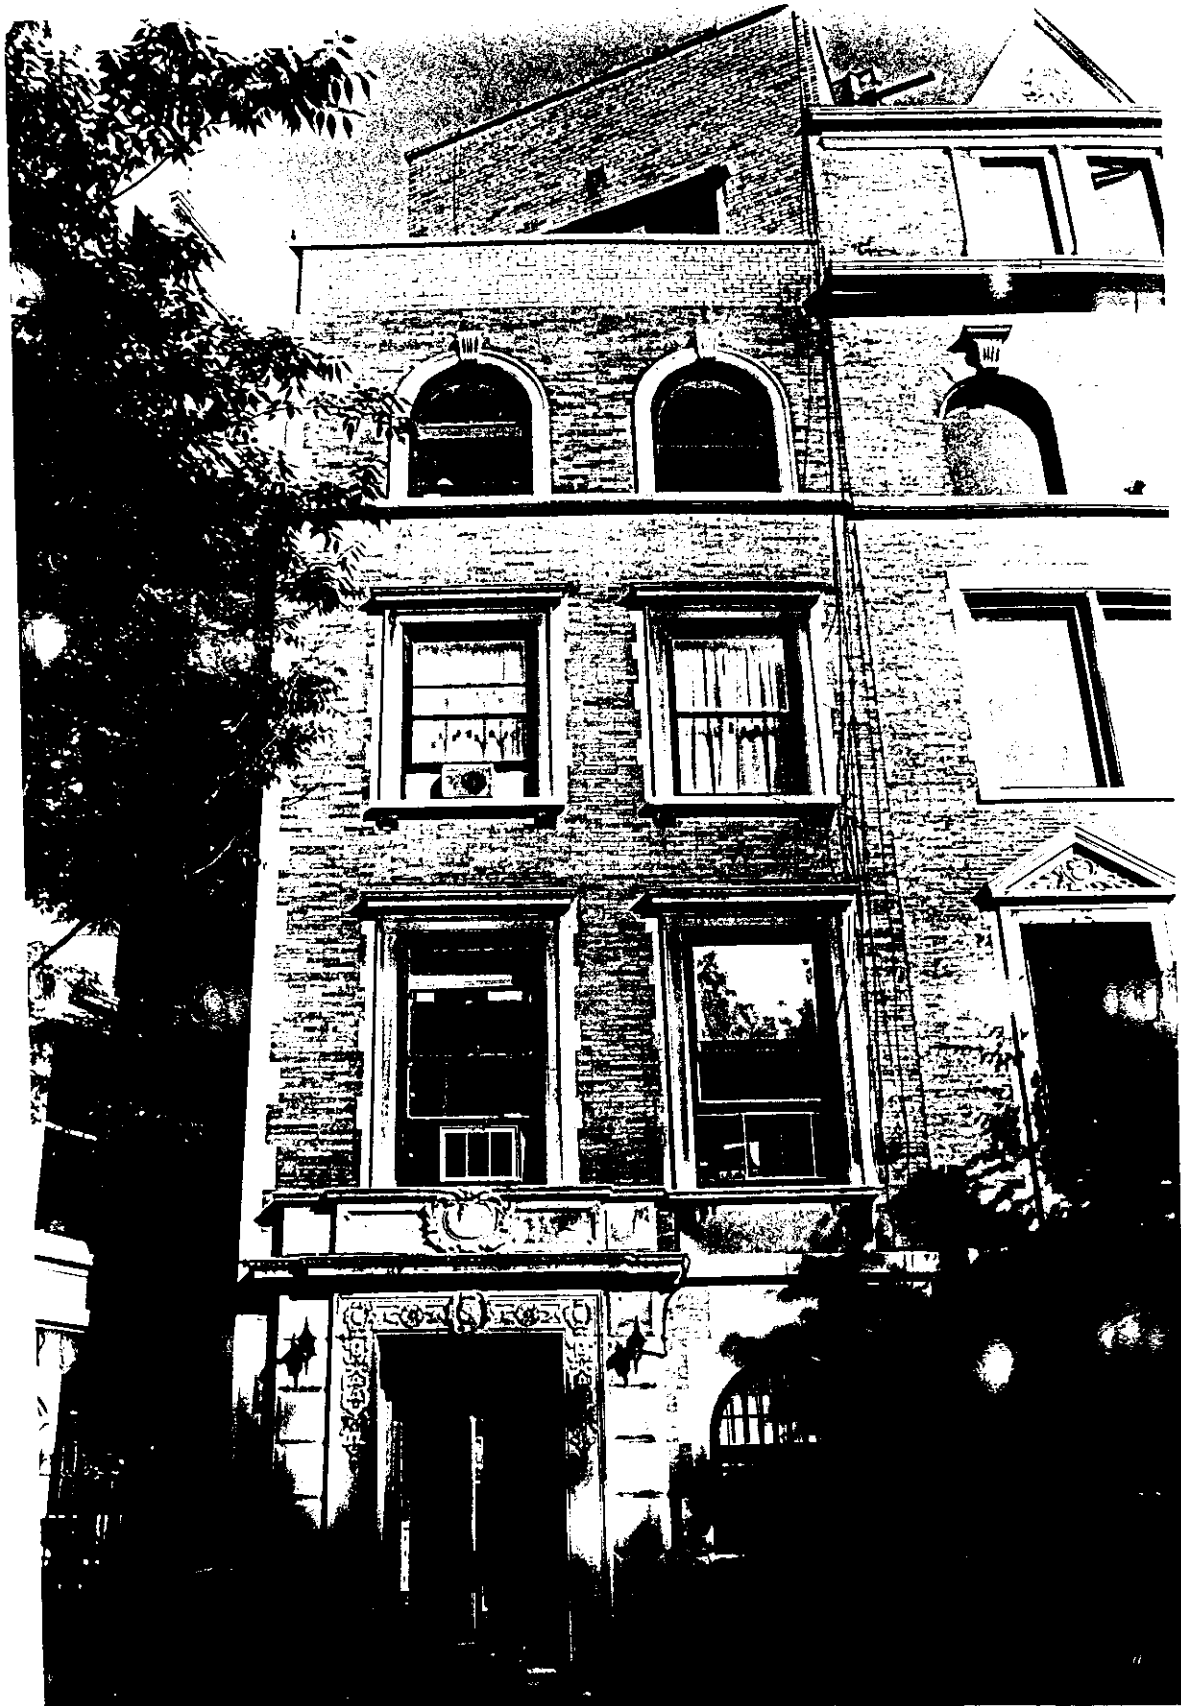
104 Riverside Drive House, 1898-99
104 Riverside Drive

Architect: Clarence F. True
Photo Credit: Lynne D. Marthey

The original design for the L-shaped 104 Riverside Drive House featured a four-story bowfront capped by a steeply pitched half-conical tile roof with a dormer, and a side courtyard. The main facade was dismantled in 1911 and rebuilt using the original materials, with some modifications, as a flat wall following the diagonal of the property line. Two bays wide, the facade is faced with light orange Roman ironspot brick and limestone trim. Original elements re-worked into the design were the watertable, the rusticated recessed entranceway with carved limestone ornament and a parapet, the ground-story round-arched window with a keyed surround, the second- and third-story rectangular windows with molded and keyed surrounds, the round-arched fourth-story windows with molded surrounds and keystones, and the quoins along the north edge of the facade. Surviving from the original design are the prominent chimney at the south end, one-over-one double-hung wood sash, and the north side of the building, facing a side courtyard bordered and divided by a wrought-iron fence with a gate. True's courtyard facades (the long side is largely unarticulated except for small windows) continue the general scheme of window surrounds: round arches on the ground story, molded and keyed surrounds on the second and third stories, and fourth-story round arches with keystones. The ground-story service entrance has been mostly filled in with brick; there is a basement entrance at the end of the court.

Modifications to the roof portion of the building in 1911 included the addition of a parapet above the cornice and the creation of a gable, faced with galvanized iron, containing a dormer with rectangular windows and a large broken scroll pediment. The face of the gable remained perpendicular to the side walls, rather than re-oriented to the new diagonal Riverside Drive facade. Apparently at the time of the building's conversion to a multiple dwelling in 1945-46 (Alt. 2019-1945), the top portion of the building received further alterations: the cornice and parapet were removed and a new brick parapet constructed, and the gable was built out (still at the same angle to the street) as a full story with three openings containing multipane sash; all of the work is of light orange brick. The entrance to the building has received metal and glass replacement doors (c. 1940-50s) and the ground-story window a wrought-iron grille.
